# **Smoke and Dye Testing Summary**

## **High Level Sewershed**

Run Summ	ary <del></del>	Data			Ground Condition	Notification		
Test ID	Test Type	Date Inspected	Company / Super.	Nearest MH		Made?	1	
D1028-162	Dye	4/22/2009	ADS/TM	S11UU_009MH	Damp	NA		
Address 3401 Rosedale Road			Location	Curb	Status P	ublic	Source	Catch Basin

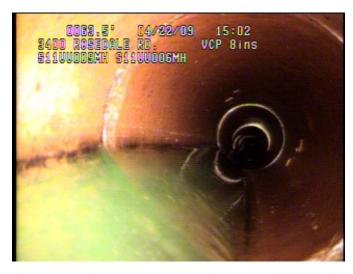
**Picture** \D1028-162-OB01-P01.jpg

**Comments** Dye observed 63.5 ft. downstream of

S11UU\_009MH. Infiltration runner at joint at 7

oclock.

**Comments** 63.5 ft. downstream of S11UU\_009MH along

S11UU\_009G1.
